## CASE STUDY: ACCOMMODATION

### GATE AUTOMATION

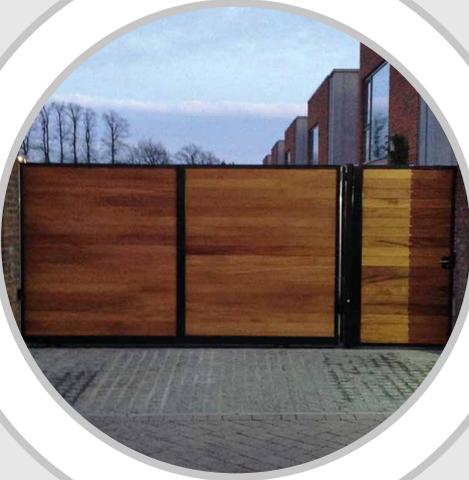
With the residents using the mailboxes on a daily basis it was proposed that a safety function was integrated to stop the sliding gate from being operated if a residents hand was in the mailbox. A Laser curtain was the solution – when the light beam is broken this sends a message to the control panel to stop the gate from opening. Once this object had been removed, the control panel will pick this up and trigger the sliding gate as per normal.
